SUBJ: RCRA Compliance Evaluation Inspection  
Mercedes-Benz US International, Inc.  
EPA ID Number: ALR000002246

## **RCRA Inspection Report**

Mercedes-Benz US International, Inc.  
1 Mercedes Drive  
Vance, Alabama 35490  
Tuscaloosa County  
EPA ID: ALR000002246

November 28, 2017 at 9:15 a.m. CST

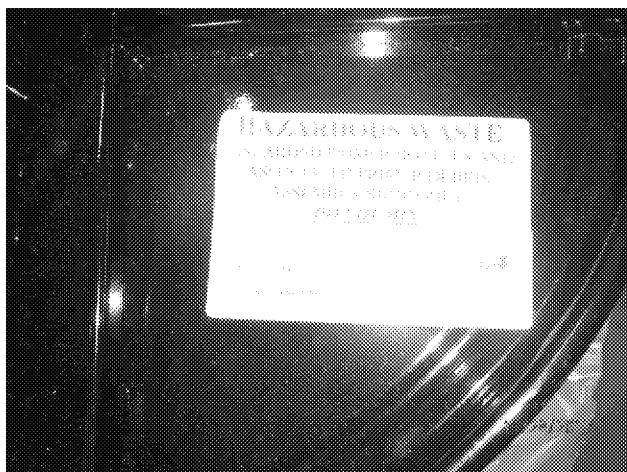
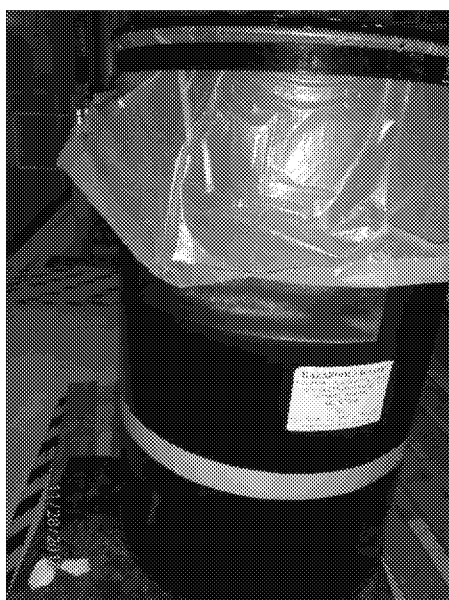
Assembly 1 Windshield Rear Glass SAA contained an open 55-gallon drum of discarded primer bottles and associated primer debris and a 55-gallon drum of non-hazardous oily debris (Pictures 1-2). Mr. Moeller closed the drum lid during the inspection. Both containers were labeled.

Picture [ SEQ Picture \\* ARABIC ] – Assembly 1  
Windshield Rear Glass SAA drum label

Picture [ SEQ Picture \\* ARABIC ] – Assembly 1  
Windshield Rear Glass SAA drum

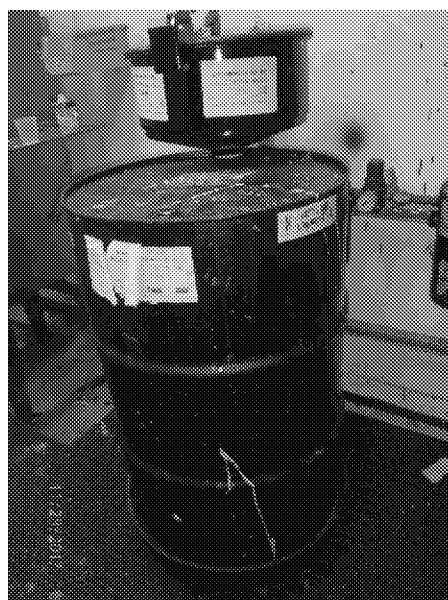
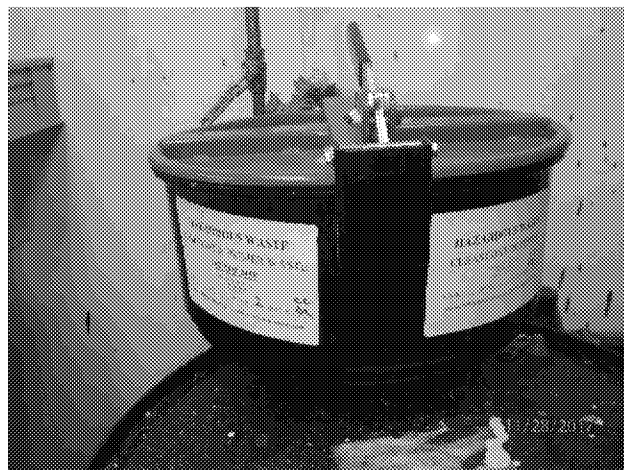
Assembly 2 Paint Mix Room had a consolidated 55-gallon drum of base coat/primer waste and clear coat/2K primer waste (Pictures 3-4). The inspectors asked why the two waste streams were combined in this area and not in Assembly 1. Mr. Moeller was not sure why the waste streams were combined but promised to ask Nexeo. In addition, Mr. Moeller stated that the waste streams

were not significantly different. The container was observed closed and labeled.

Picture [ SEQ Picture \\* ARABIC ] – Assembly 2 Paint  
Mix Room consolidated paint waste drum

Picture [ SEQ Picture \\* ARABIC ] – Assembly 2 Paint  
Mix Room SAA drum with two labels

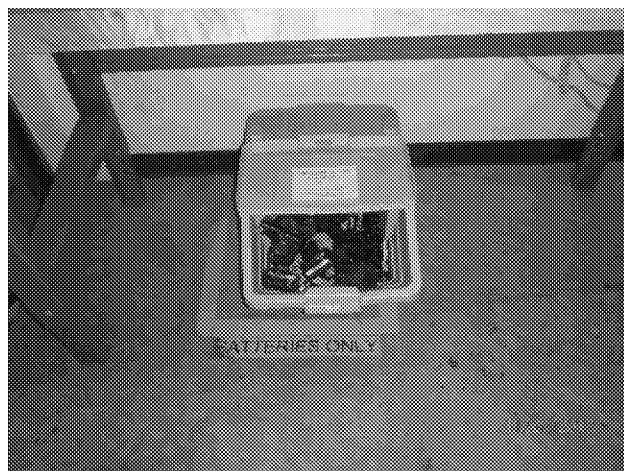
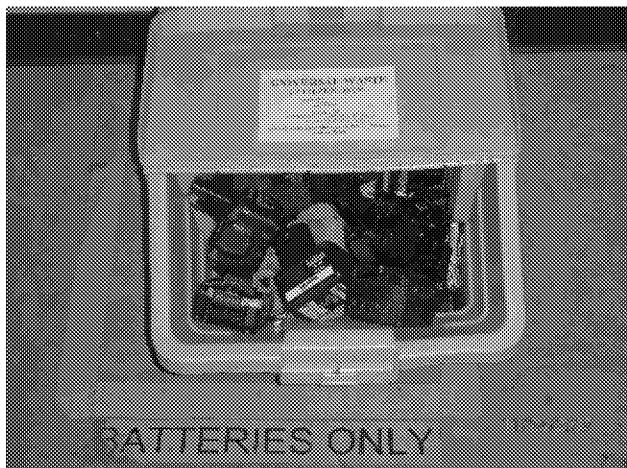
Outside of the Assembly 2 entrance was the Supply Shop. The inspectors observed a yellow bin of universal waste batteries (Pictures 5-6). The bin was labeled and dated.

Picture [ SEQ Picture \\* ARABIC ] – Assembly 2 Supply

Picture [ SEQ Picture \\* ARABIC ] – Assembly 2 Supply Room UW battery container

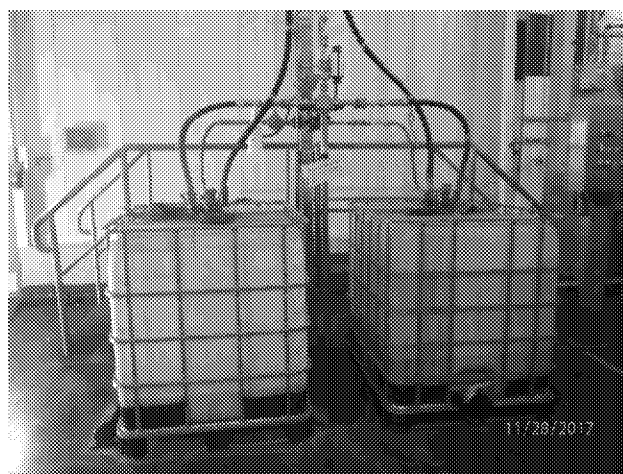
In the same area was a waterborne waste recovery system with two 300-gallon totes used to collect non-hazardous waste water from the paint purge system and send it to the waste water treatment plant (Picture 14). At the time of the inspection, the system was not in operation and a hazardous waste label had been placed on the totes. Mr. Moeller confirmed that the labels were incorrect and removed them immediately.

Picture [ SEQ Picture \\* ARABIC ] – Paint Shop waterborne waste recovery system

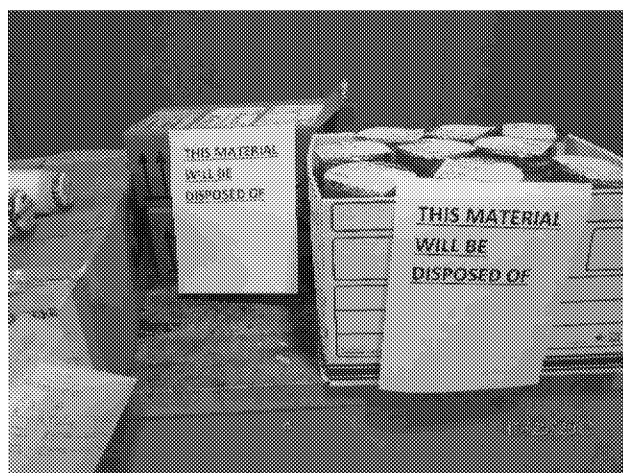
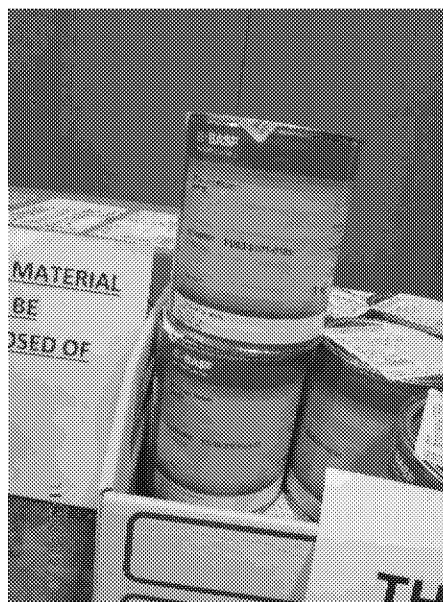
Outside the purge and blending area, the inspectors observed a table with two boxes of discontinued BASF white primer (Pictures 15-16). Mr. Moeller believed that the containers were waiting for pickup by Nexeo.

Picture [ SEQ Picture \\* ARABIC ] – Paint Shop boxes of expired primer

Picture [ SEQ Picture \\* ARABIC ] – Paint Shop boxes of

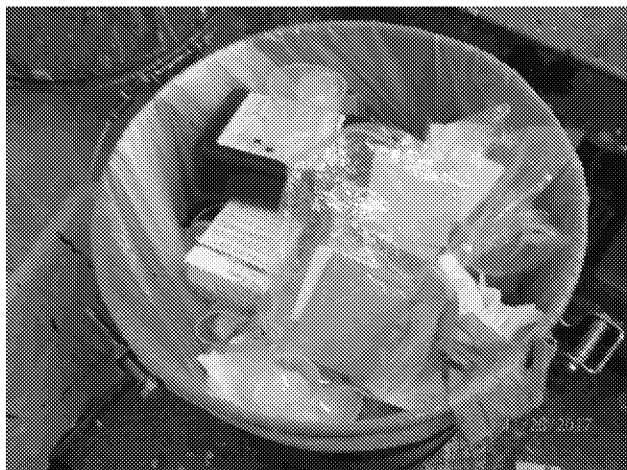
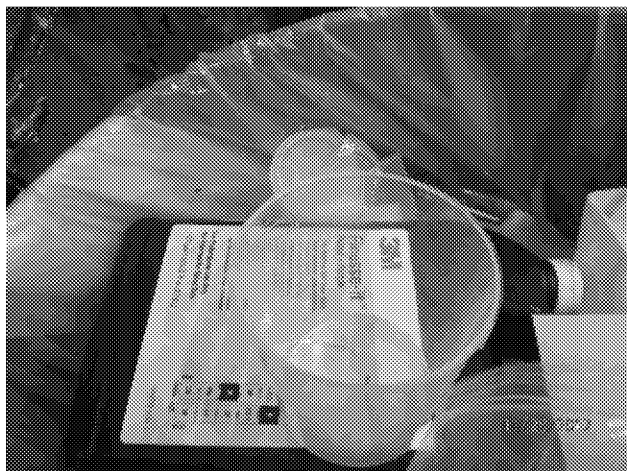
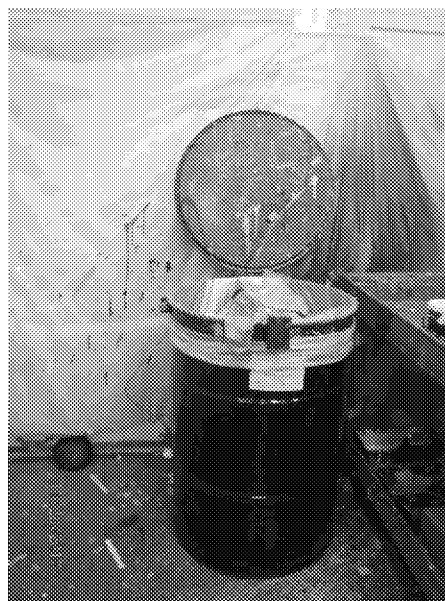
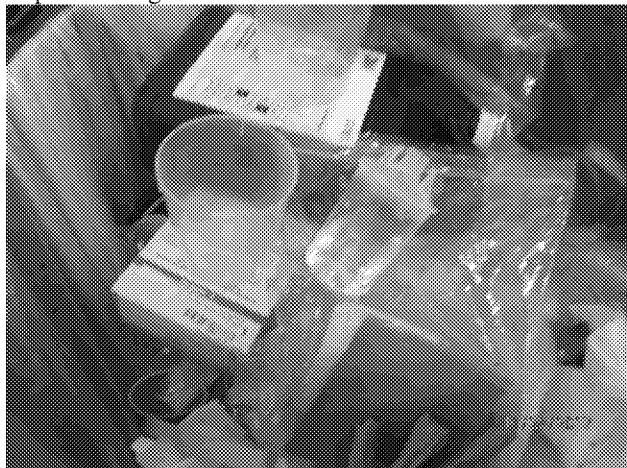
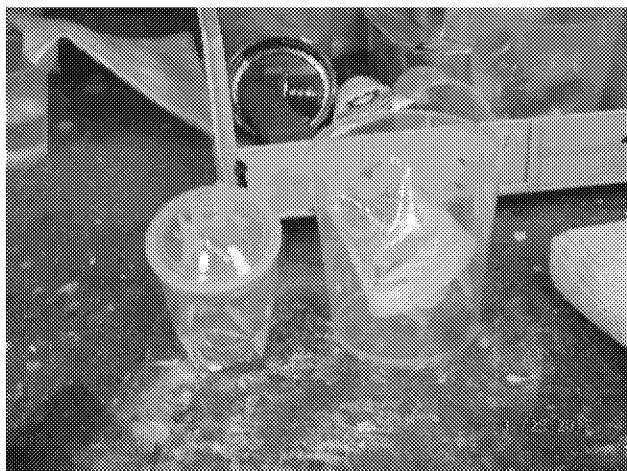
- A fume hood with used paint filters (Picture 19)
- An open 55-gallon drum of waste clear coat solvent (Pictures 20-21)
- An empty 55-gallon drum for waste clear coat solvent (Picture 20)
- A non-hazardous waste drum of clear coat contaminated debris (Picture 22), and
- A pint cup and two small applicator containers of used liquid clear coat discarded in the non-hazardous waste drum (Pictures 17-18, 23-24).

Ms. Davidson and Mr. Moeller closed the open drum during the inspection. Mr. Moeller removed the small containers of used liquid clear coat from the non-hazardous waste drum. Mr. Moeller explained that once the clear coat started to thicken it was no longer usable. The paint technician should have allowed the liquid to fully harden before discarding into the non-hazardous waste drum, thus rendering the waste non-hazardous. As a liquid the clear coat is still considered hazardous, and thus was improperly disposed of.

**Pursuant to ADEM Admin. Code r. 335-14-3-.03(5)(a)4. [40 C.F.R. § 262.34(a)(4)], which incorporates ADEM Admin. Code r. 335-14-9 [40 C.F.R. § 268], and is a condition of the LQG Permit Exemption, a generator is required to comply with land disposal restrictions (LDR) for hazardous waste.**

Picture [ SEQ Picture \\* ARABIC ] – Paint Shop Paint Repair Mixing Room non-HW drum

Picture [ SEQ Picture \\* ARABIC ] – Paint Shop Paint Repair Mixing Room liquid clear coat container in non-HW drum

Picture [ SEQ Picture \\* ARABIC ] – Paint Shop Paint Repair Mixing Room liquid clear coat container in non HW drum

Picture [ SEQ Picture \\* ARABIC ] – Paint Shop Paint Repair Mixing Room liquid clear coat container improperly disposed of

The inspectors advised that more containers of liquid clear coat may be in the non-hazardous waste drum and should be removed. Additionally, refresher training on the proper disposal of the used liquid clear coat should be addressed. Mr. Gerry Kain, Manager stated that refresher training had already been implemented for this issue during the inspection.

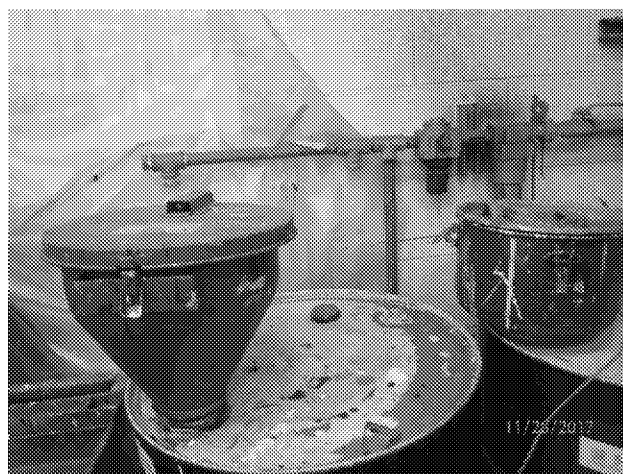
Picture [ SEQ Picture \\* ARABIC ] – Paint Shop Paint Repair Mixing Room open SAA drum

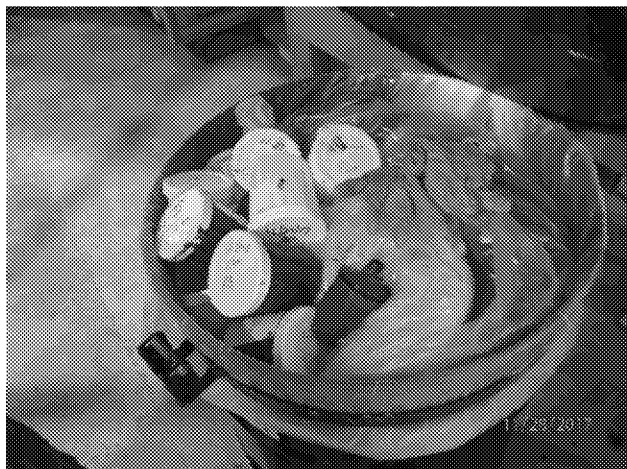
Outside the Paint Booth was a non-hazardous waste drum containing a gray tube of liquid base coat and primer and several pint containers of discarded liquid paint (Picture 25). Mr. Moeller stated that no liquid waste was to be disposed of in the non-hazardous waste drums. Mr. Moeller also stated that containers of liquid were non-hazardous but still should not have been placed in this drum.

Picture [ SEQ Picture \\* ARABIC ] – Paint Shop paint

line non-HW drum filled with liquid containers of paint waste

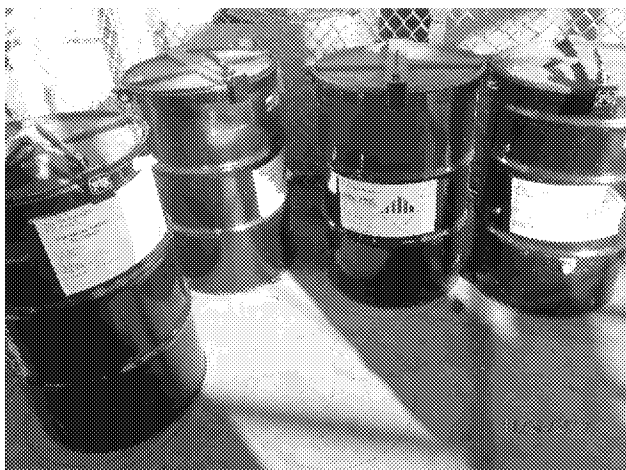
- Fourteen 4- and 8- foot spent fluorescent lamp boxes on a pallet (Picture 30). The boxes were closed, labeled with the oldest dated April 14, 2017.
- A 55-gallon drum of spent alkaline batteries (Picture 31)
- A 55-gallon drum of discarded airbags labeled as non-RCRA material and dated October 2, 2017. The inspectors advised Mr. Slovensky to properly label the drum as hazardous waste (Picture 31).

**Pursuant to ADEM Admin. Code r. 335-14-3-.03(5)(a)3. [40 C.F.R. § 262.34(a)(3)], which is a condition of the LQG Permit Exemption, a generator is required to label or clearly mark each container and tank accumulating hazardous waste on-site with the words: “Hazardous Waste.”**

Observation: An airbag was observed in a container labeled nonhazardous waste. The label was corrected during inspection.

Picture [ SEQ Picture \\* ARABIC ] – HazMat universal waste batteries, crushed lamps and airbags

- MBUSI Response: A retraining of all Nexeo personnel took place on 11/29/2017 to review proper drum labeling, including labeling of airbags as hazardous waste.

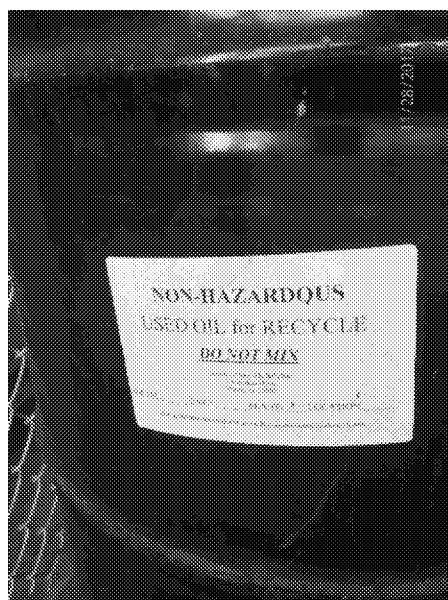
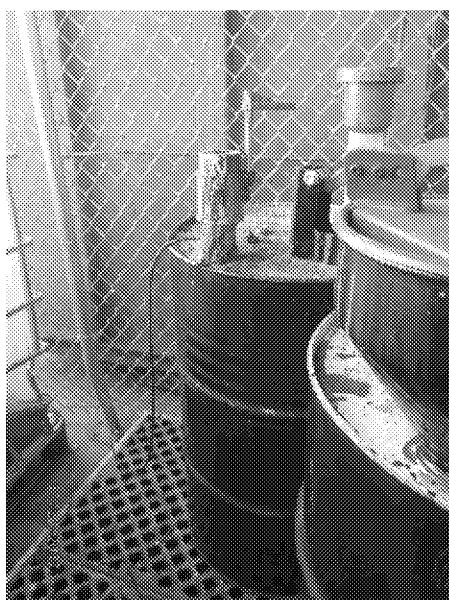
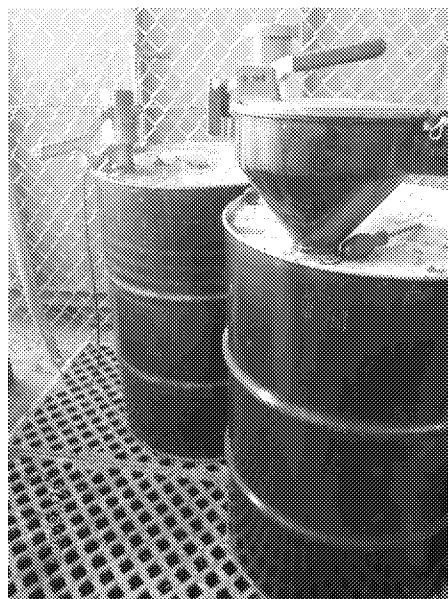
The inspectors observed an aerosol can puncture system on top of a 55-gallon drum that was labeled as “used oil” (Picture 37). The aerosol can puncture system was observed open at the time of the inspection (Pictures 36, 38). Mr. Slovensky closed the puncture system lid. However, the label was incorrect and should be marked as “hazardous waste”.

**Pursuant to ADEM Admin. Code r. 335-14-3-.03(5)(c)1.(ii) [40 C.F.R. § 262.34(c)(1)(ii)], which is a condition of the SAA Permit Exemption, a generator is required to mark satellite accumulation containers either with the words “Hazardous Waste” or with other words that identify the contents of the containers.**

Observation: A hazardous waste puncture and drain unit was incorrectly labeled as “used oil.” The same unit was observed not closed but was corrected during inspection.

Picture [ SEQ Picture \\* ARABIC ] – HazMat spent aerosol can puncture system labeled incorrectly as “Used Oil”

Picture [ SEQ Picture \\* ARABIC ] – HazMat spent aerosol can puncture system open

Picture [ SEQ Picture \\* ARABIC ] – HazMat spent aerosol can puncture system and discarded solvent debris drum
